Application of the ultrasonic transmission tomography for inspection of the petroleum tank floor

R. Raišutis, R. Kažys, L. Mažeika, R. Šliteris

Ultrasound Institute, Kaunas University of Technology, Lithuania

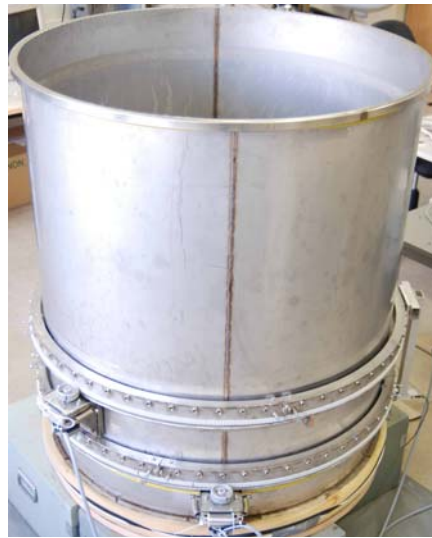
Fig.2. Photo of the 1:8 scaled down size tank mock-up (a) and the measurement set-up (b) used for investigation

For experimental investigation the scaled down size tank mock-up (scaling factor 8:1) placed on wet sand and filled with water was selected (Fig.2a). The internal diameter of the tank was 1 m, the height 1.1 m, the thickness of the floor plate was 1 mm. The experimental set-up used in the investigation and the plates arrangement of the welded floor is presented in Fig.2b.

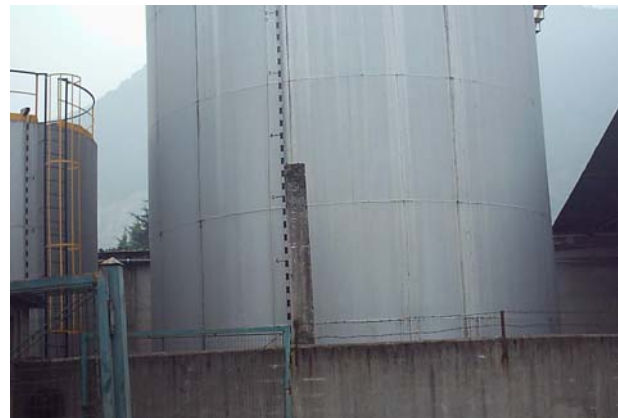
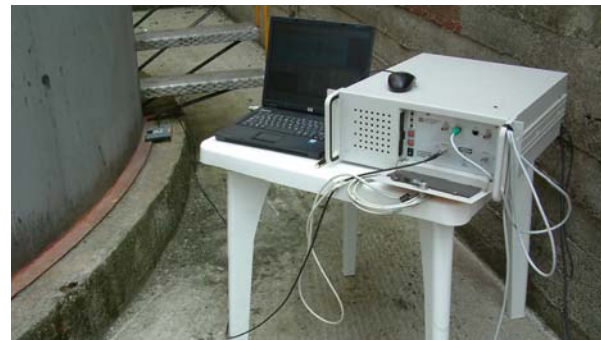
Fig.5. Application of the transmission tomography for inspection of a petroleum tank floor: a - photo of the real tank, which is necessary to inspect, b - experimental set-up, c - the transmitter and receiver positions during *in situ* experiments

In order to estimate the performance of the developed reconstruction algorithm, the experimental measurements have been carried out *in situ* on a small 8 m diameter tank (Fig.5 a), with the step 25 cm along the circumference of the tank floor. The total number of measurement points was 441. In the measurements 50 kHz ultrasonic transducers were used. The transducers were attached to the edge of the tank floor using liquid coupling and magnetic fixing. The tank floor edge was prepared in advance by grinding. For the signal excitation and reception the ultrasonic imaging system developed by the Ultrasound institute of Kaunas University of Technology was used (Fig.5 b). The transmitters were excited using the three periods burst.

In such a way the number of projections was acquired. The projection in the ultrasonic transmission tomography is assumed to be the distribution of the attenuation versus transmission direction or angle (Fig.5 c) for one transmitter position. In our case the transmitter was attached to the edge of the tank floor on one side and receivers were placed at different points on the opposite side of the tank floor covering approximately 180° sector. At each position from the acquired signals the relative attenuation (losses) are measured. The other projections are acquired in a similar way, only the transmitter is attached to the edge of the floor at different positions with some step from the previous one and the measurements on the opposite side of the tank in a corresponding sector are performed. In general, the tomography requires as much as possible of different projections, because the accuracy and resolution of the reconstructed images depend on the number of projections. On the other hand, the accuracy depends on the wavelength of the exploited Lamb wave. So, the optimal number of projections should be determined for each particular case. During investigations 9 tomographic projections were acquired (Fig.5 c). To increase reliability and reduce a noise at each point 11 measurements were performed.
